Preliminary Report RRD23MR005

# Norfolk Southern Railway Train Derailment with Subsequent Hazardous Material Release and Fires

East Palestine, Ohio  
February 3, 2023

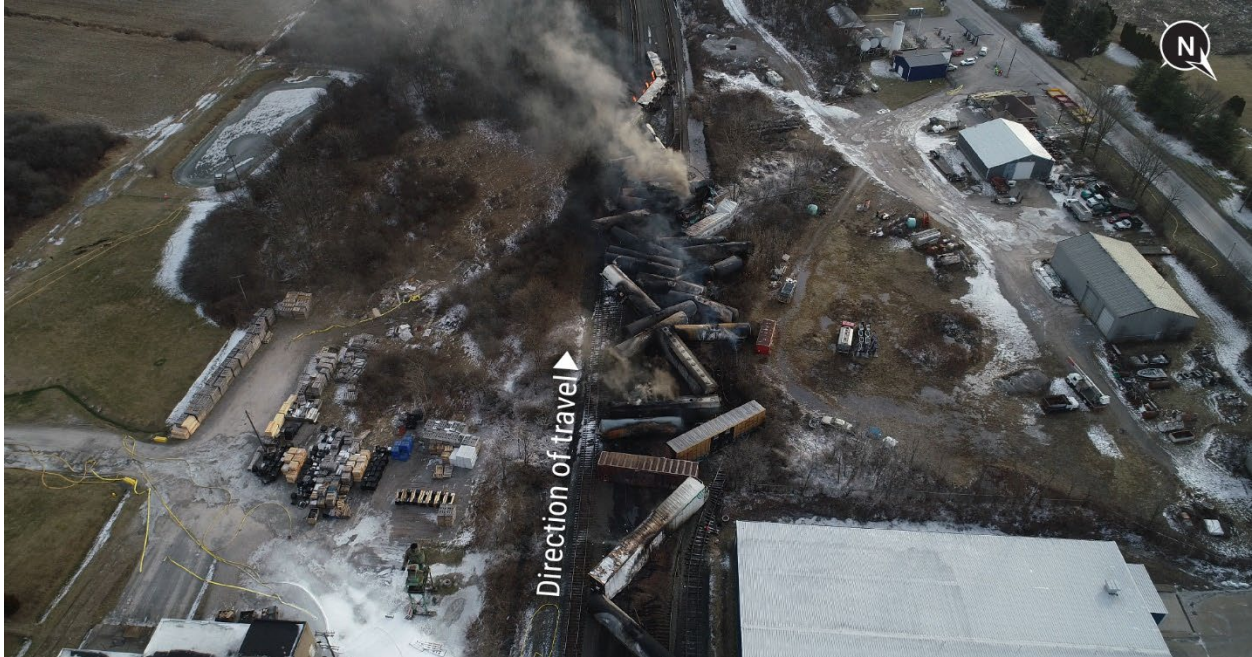
On February 3, 2023, about 8:54 p.m. local time, eastbound Norfolk Southern Railway (NS) general merchandise freight train 32N derailed 38 railcars on main track 1 of the NS Fort Wayne Line of the Keystone Division in East Palestine, Ohio.<sup>1</sup> (See figure.) The derailed equipment included 11 tank cars carrying hazardous materials that subsequently ignited, fueling fires that damaged an additional 12 non-derailed railcars. First responders implemented a 1-mile evacuation zone surrounding the derailment site that affected up to 2,000 residents. There were no reported fatalities or injuries. At the time of the accident, visibility conditions were dark and clear; the weather was 10°F with no precipitation.

Figure. Aerial photograph of derailment site.
